UCL Denys Lodge - CCTV Survey Report : 19/10/15

Name : KENT DRAINAGE LIMITED
 Contact : Tom Coe
 Location : Suite 28, Churchill Square
 Town : Kings Hill
 Region : Kent
 Postcode : ME19 4YU
 Tel : 01622 919012
 Mobile :
 Email : info@kentdrainage.co.uk
 Fax :

Name : UCL Ifor Evans Denys Lodge
 Contact :
 Location : 109 Camden Road
 Town : London
 Region :
 Postcode :
 Tel :
 Mobile :
 Email :
 Fax :

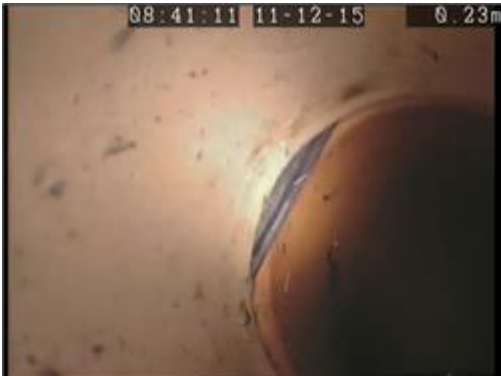
| Position | Code | Description | CD | Pic | Grade |
|---|---|---|---|---|---|
| 00.23m | SR | Sealing ring intruding 9-11 | | 7_2 | 2 |

| Pos | Code | Description | Image |
|---|---|---|---|
| 00.23m | SR | Sealing ring intruding from 9 o'clock to 11 o'clock - Grade 2 | <p>Image Provided - Ref: 7_2</p> |
